Proceedings of the 6th Annual Conference

**29 November 2022
Tallinn, Estonia**

SCANNING ELECTRON MICROSCOPY AND X-RAY MICROANALYSIS OF THE CONDITION OF CONCRETE STRUCTURES OF A CHEMICAL ENTERPRISE WITH LONG-TERM CORROSION IN A SULFATE ENVIRONMENT

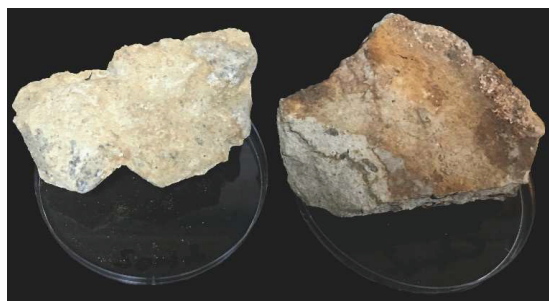
Long-term operation of reinforced concrete structures in aggressive environments of chemical enterprises affects the state of concrete surfaces and certainly leads to the development of corrosion processes. Signs of corrosion on the concrete walls in the titanium dioxide production shop were noticeable even with visual inspection as a change in the color of the surface of individual areas from light gray to yellow and dark red. To study the nature of this phenomenon, samples were taken (Fig. 1) and the state of the microstructure of the surface and side chip of concrete and the content of chemical elements were studied.

Fig. 1. Typical view of concrete samples from the walls of the shop for the production of titanium dioxide by the sulfate method
